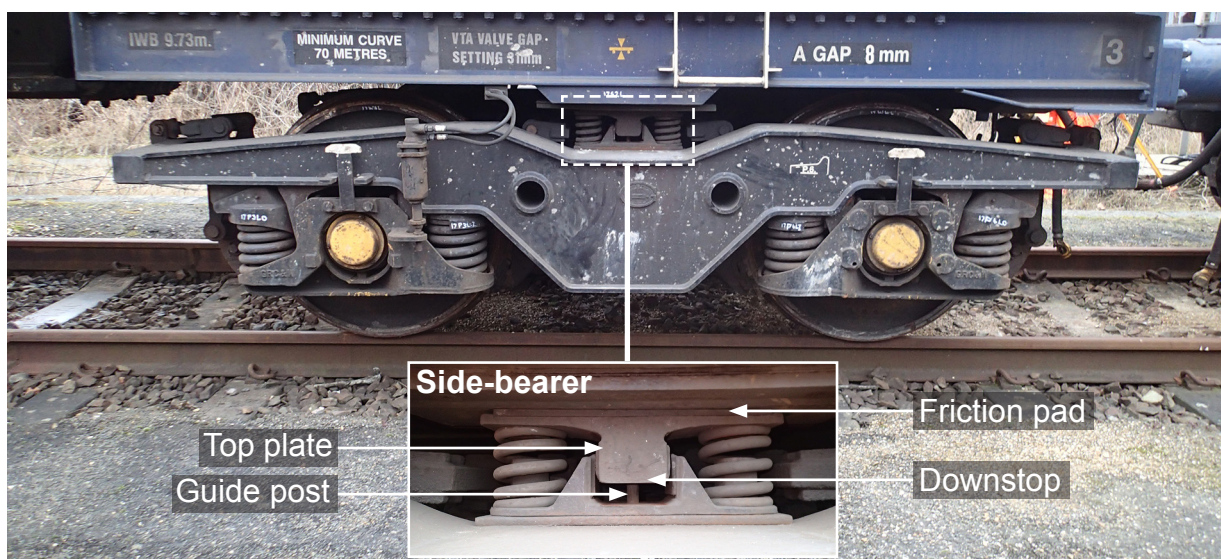
Figure 5: GPS 22.5 bogie

- 19 The bogies are of the GPS 22.5 type manufactured by the Gloucester Railway Carriage and Wagon Company. They comprise a fabricated steel bogie frame supported on four pedestal primary suspension units, each with dual coil springs and a wedge-operated damper arrangement designed to provide a friction force that increases with carried load (figure 5). The wagon body is supported on a conventional UIC-type secondary suspension: a hemispherical *centre pivot*, with a composite friction liner, and a pair of *side-bearers*, each comprising a coil sprung top plate with a friction pad on the top and a metal *downstop* underneath (figure 5 inset).
